Lets Get Retrofitting

Filtration— An Assured Savings Choice

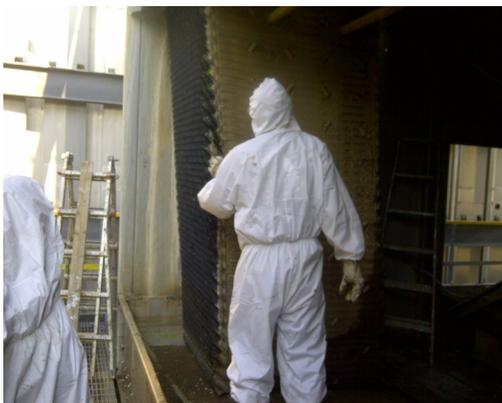
This month's photo is of a six-cell cooling tower fill replacement at a prominent university; the third replacement in 15-years. The debris shown was not only introduced from the air inlet; but also through the distribution nozzles. These towers do not have filtration. With a properly sized filtration system the amount of debris will be significantly reduced, extending the overall life of the fill.
